# SERVICE BULLETIN

**WORL DLAWN POWER EQUIPMENT, INC.**

**Bulletin Number: SB1101**

**Model:** WYZ48/52/60 & WYRZ50 Zero Turn Models

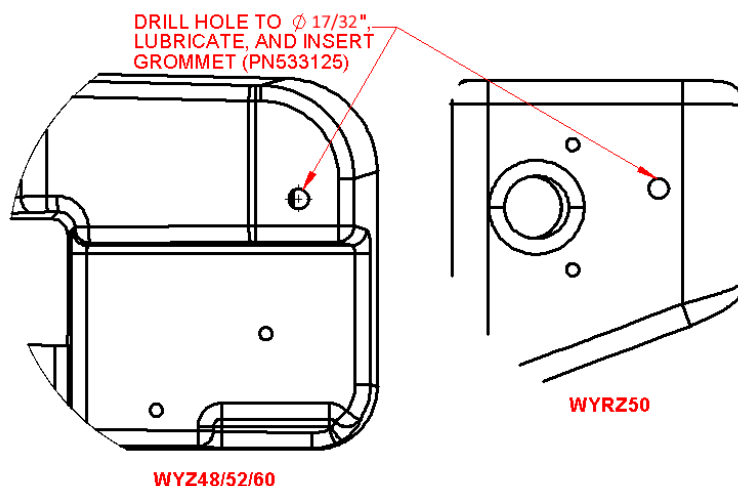
**Subject:** In a continuing effort to improve product, we have changed to a new grommet style. Field reports have indicated that tank leakage may occur. When replacing grommet, increase the hole size to 17/32". Please contact dealers and various customers that this may affect.

- Ensure that all fuel has drained from tank.
- Remove bolts from tank mounts, tip tank, and drill hole to 17/32" diameter.
- Lubricate new grommet (PN533125) with P-80 THIX Rubber Lubricant Gel or an equivalent product (not harmful to rubber products). Insert grommet into drilled hole and push right angle connector into grommet. (Make certain that grommet is seated firmly and evenly.)
