SERVICE BULLETIN

WORLDLAWN POWER EQUIPMENT, INC.
2415 Ashland Ave
Beatrice, NE 68310
(402) 228-4255

Bulletin Number: SB1404
Date: 5/30/14

Product Affected: WYK52FX730V5 & WYK60FX801V5 King Cobra mowers with serial numbers 201403U00817 through 201404U00989

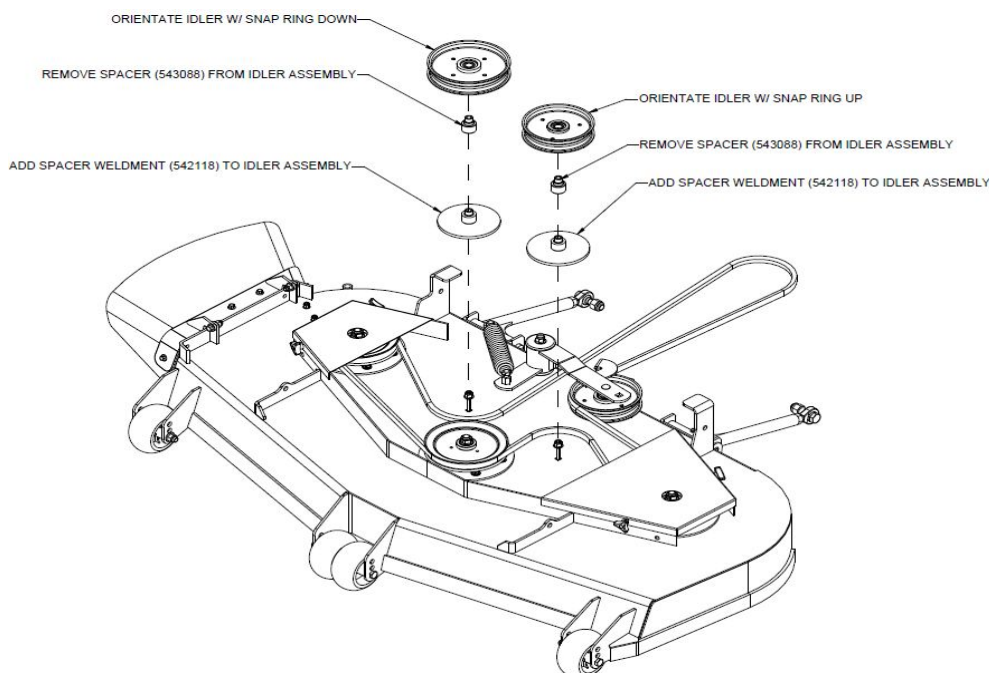
Situation: We had several field complaints on units with low hours where the deck has bent under the stationary idler pulley. When the deck bends the idler pulley may tip or lean over. The resulting misalignment may cause the belt to come off.

Solution: A reinforcement plate was added to all units in production and in inventory. All units in distributor, dealer, and retail inventory should be updated as soon as practical. A kit was developed which contains two reinforcement plates, one for each of the stationary idlers.

Parts Required: 542121 reinforcement kit
One kit per unit.

Important Note The large idler needs to be installed with the snap ring on top. The small idler needs to be installed with the snap ring on the bottom.
